MISCELLANEOUS PAPER GL-87-30

# CONDITION SURVEY AND PAVER IMPLEMENTATION MACDILL AUXILIARY FIELD NO. 1 (AVON PARK RANGE), FLORIDA

November 1987

Final Report

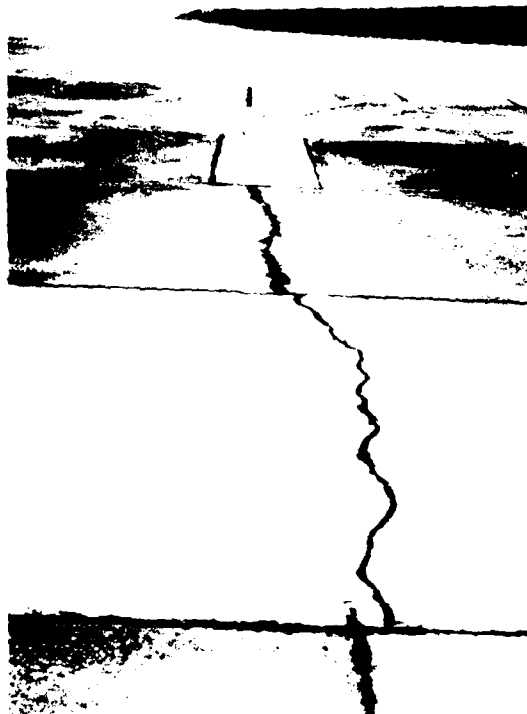
Photo 1. Typical cracking and  
patching in PCC, Runway 5-23

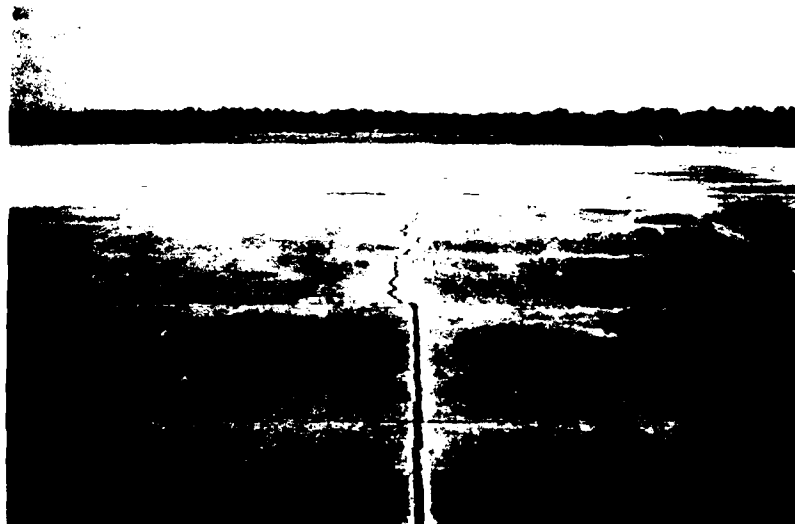
Photo 5. View of cracking caused by uncut joint,  
Apron E
